## **Pwllheli Harbour Crib Groyne Assessment and Review**

**September 2017**  
**Draft Report**

# Pwllheli Harbour Crib Groyne Review and Assessment September 2017

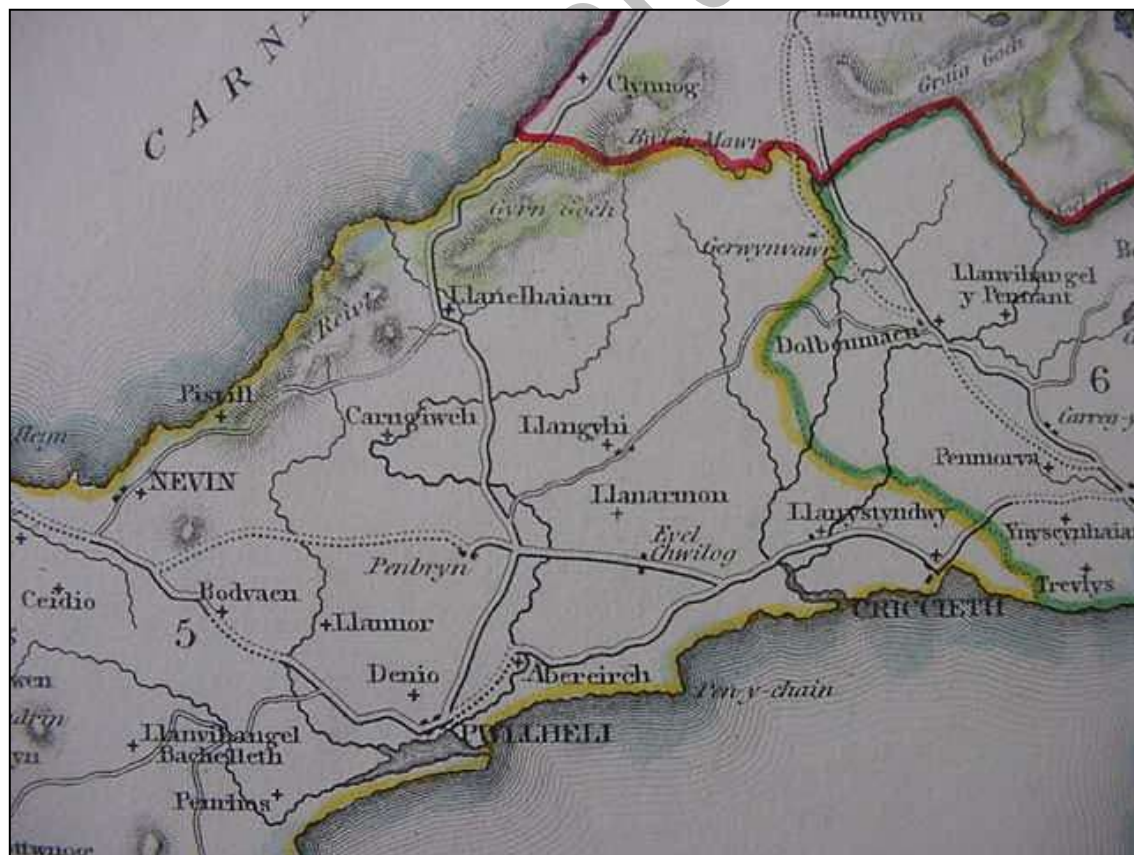
From the late 16th Century to the early 19th century maps show Pwllheli at the confluence of the three rivers (Afon Penrhos, Rhyd-hir and Erch) with the Cardigan Bay facing frontage effectively a spit of land surrounded by water with Carreg yr Imbill at its eastern end (see Figure 3).

**Figure 3: Historical Maps from Early 19<sup>th</sup> Century**  
 (Top: William Morris c1801- Bottom: Robert Creighton c1835-1848)<sup>17</sup>

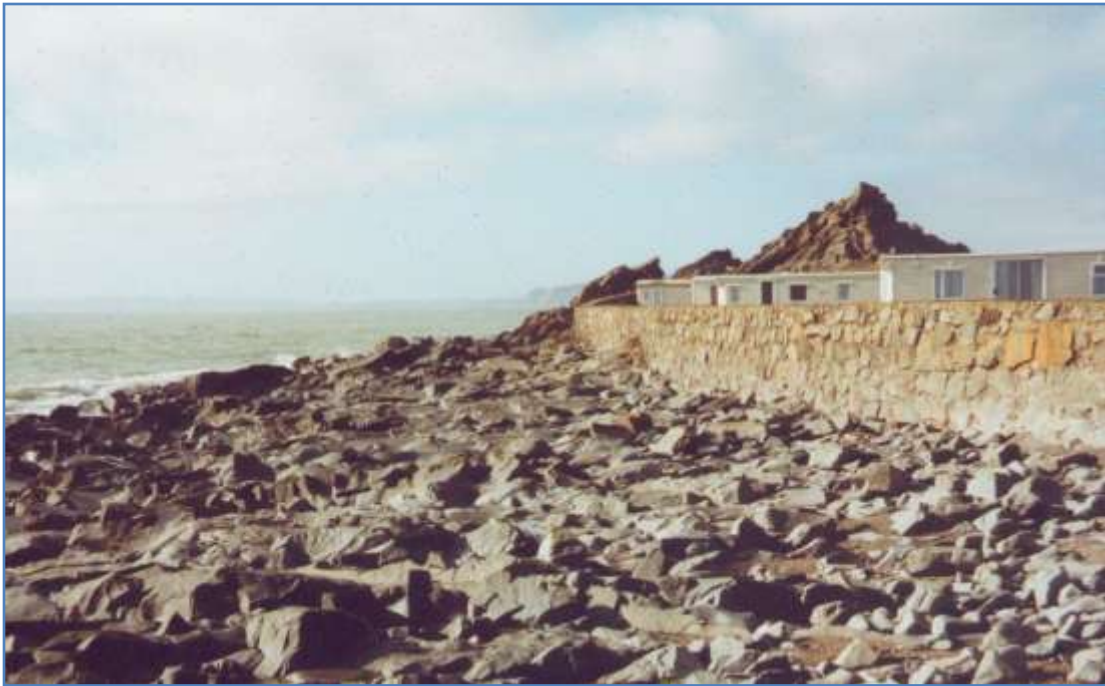
Plate 1: Rock Foreshore in front of Gimlet Rock Caravan Park

Working north eastwards from the headland of Carreg yr Imbrill, the foreshore initially comprises low level rock outcrop which is intermittently covered with a mixture of sand and shingle. This section fronts the Gimblet Rock Holiday Park, with a vertical masonry wall at the top of the beach, which provides protection to the holiday park infrastructure (ref Plate 1).

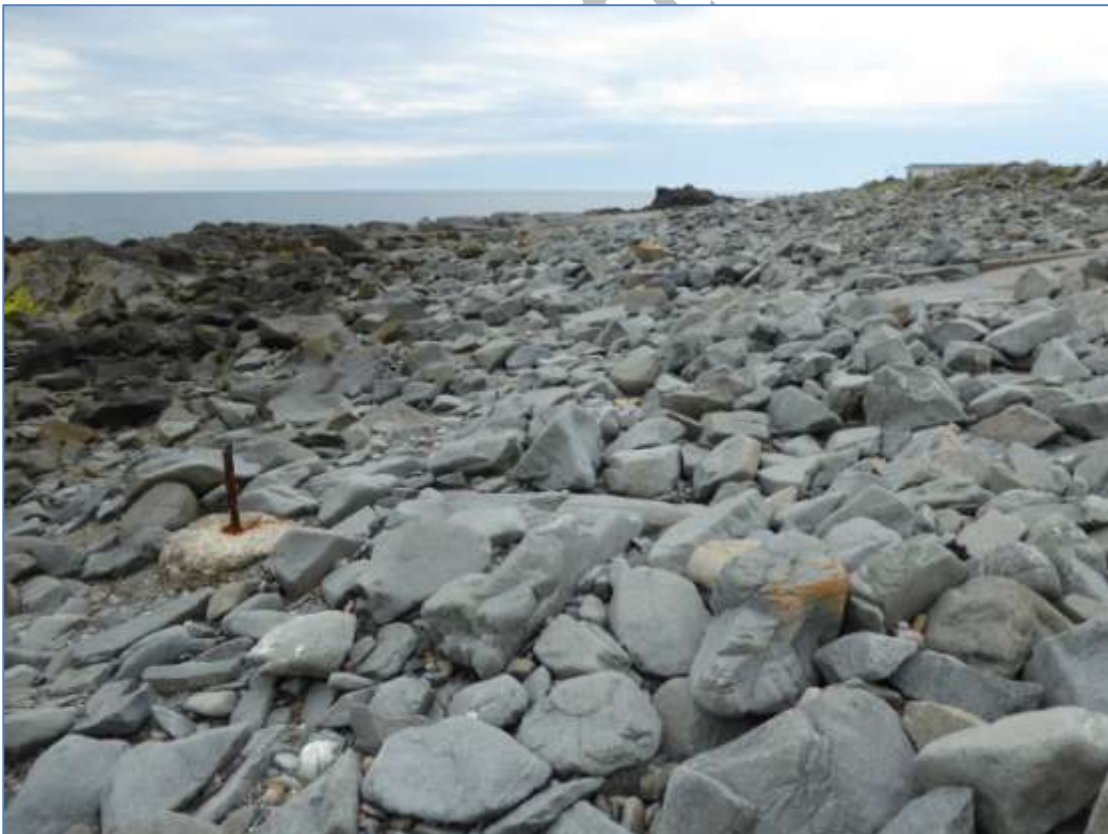
Plate 2: Rock Foreshore in front of Gimlet Rock Caravan Park

Moving north easterly the outcropping bedrock reduces and the beach becomes a mixture of small boulders, cobbles and shingle (Plate 2). At the top of the beach the vertical wall gives way to a low level earth embankment supplemented by large boulders with the lower parts of the beach becoming finer moving towards the harbour mouth (Plate 3). The exact provenance of the boulders is unknown but it is thought they are probably arisings from the quarry that operated at Gimblet Rock, which is shown on OS plans from 1891-1960s (ref Appendix A: Historic OS Plans). This embankment continues longshore to the landward end of the crib groyne.

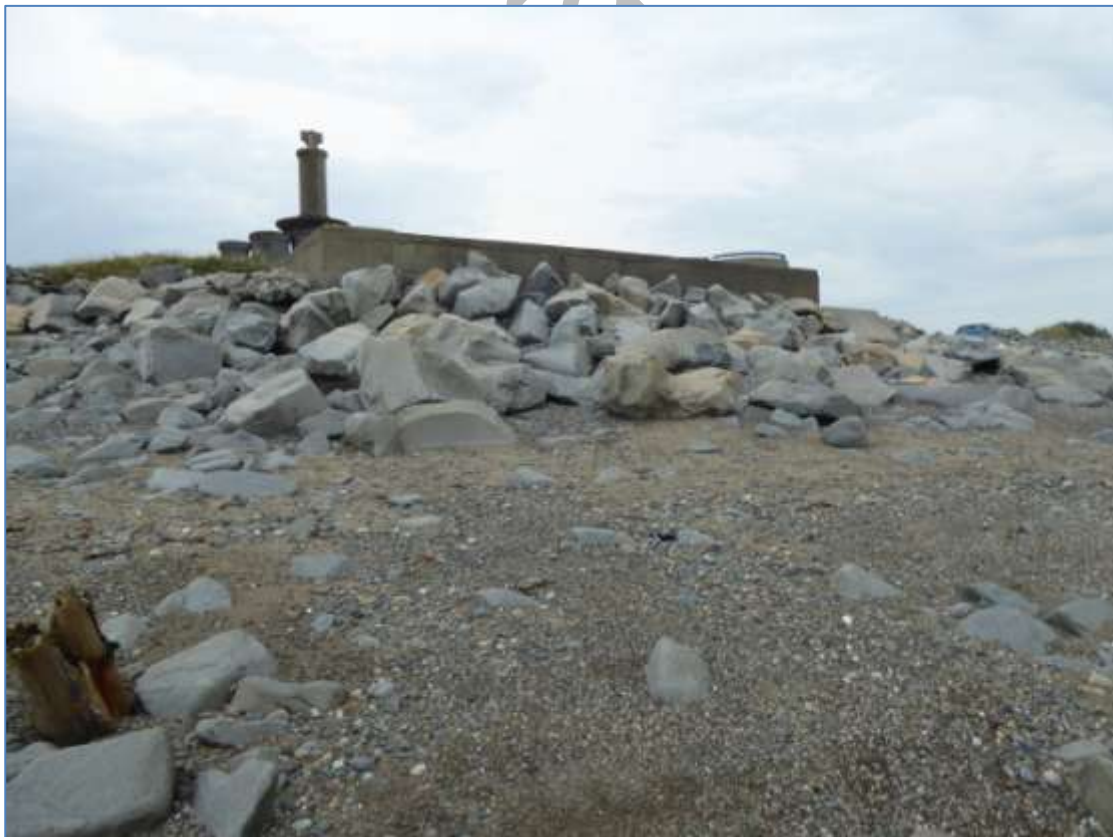
Plate 4: Protection to Dwr Cymru Holding Tank

Approximately 100 metres south of the crib groyne there is a Dwr Cymru Holding Tank, which is protected by a vertical sea wall with some large boulders placed in front (Plate 4). This holding tank is fed by a rising main on the south side and is connected to an outfall on the north side that runs longshore towards the crib groyne and then alongside the upstream side of the crib groyne<sup>3</sup>. Between the holding tank and the crib groyne the upper beach comprises predominantly boulders and cobbles with the lower parts of the beach comprising finer sediment, generally a mixture of sand and shingle (Plate 5). Moving towards the groyne the boulders have been mounded up into an informal defence along the crest (Plate 6).

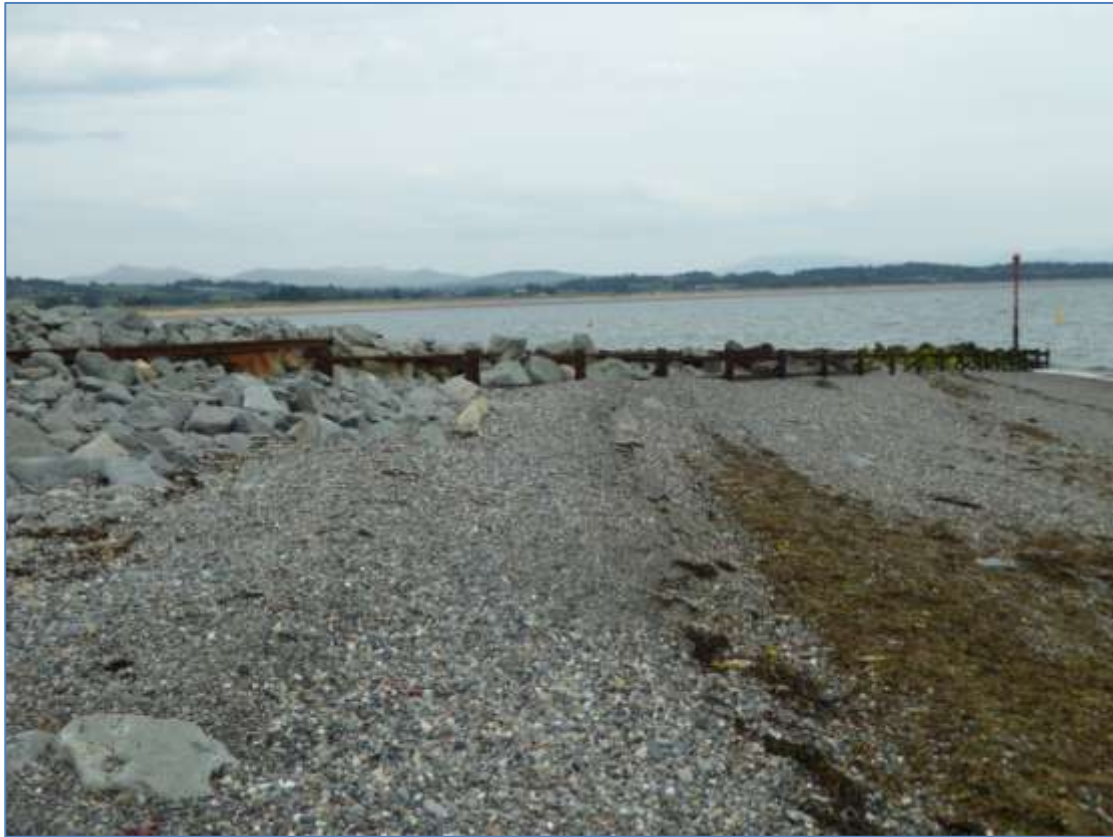
On the updrift side of the groyne approximately 17 piles are visible with only the top 700-800mm of the groyne visible (Plate 7). The top walings have been damaged on this side with sections of them missing and/or bent across and over the groyne (Plate 8). On the downdrift side there are sections of damaged walings, that have been removed from the other side of the groyne, lying on the beach (Plate 9). The walings on this side remain in situ with the top three walings visible at the seaward end of the groyne (Plate 10). Moving up the groyne, the beach level increases, with only two walings visible (Plate 11). Similarly 17 piles are visible with the top 10 pile sets on both sides completely covered by a mixture of boulders (Plate 12).

Plate 7: Side Elevation of Crib Groyne on Updrift Side

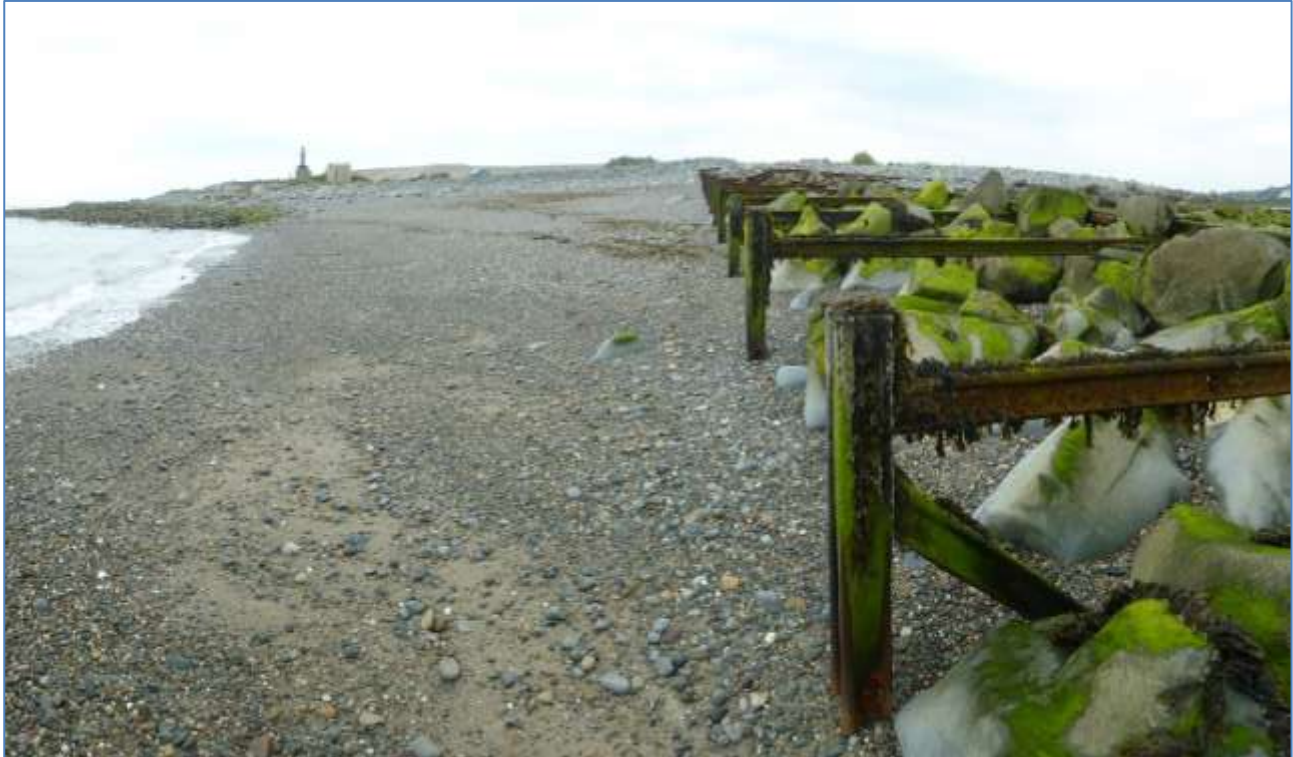
Plate 8: Missing side walings on updrift side of groyne

- Replacement of damaged walings;
- Removal of the upper pieces of rock armour within the crib groyne and replacement with a layer of larger imported rock armour that will be more resistant to movement by wave action; and
- Localised reshaping of small boulder protection at the landward end of the groyne.

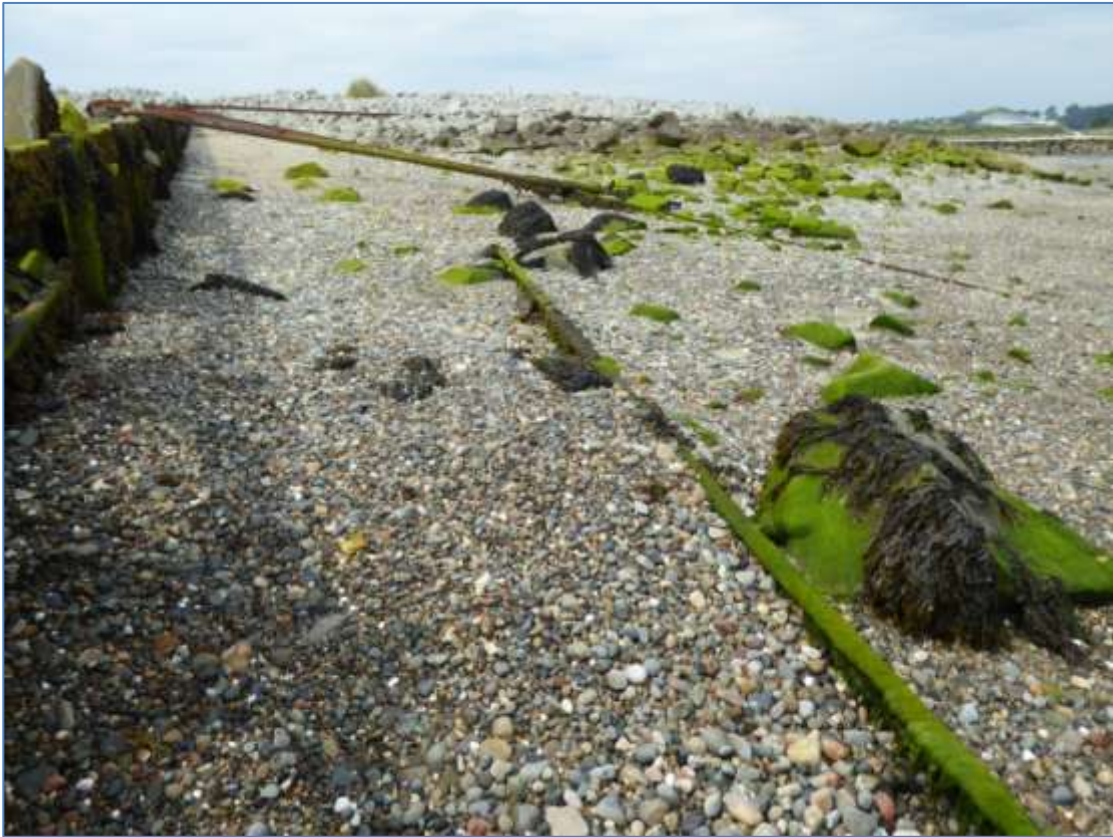
Within the groyne the rock armour has been moved about, particularly from the downdrift side where the walings have been damaged/removed (Plate 13). This armour has been moved by wave action and there is evidence that some of it has been deposited on the beach on the downdrift side (ref Plate 9).

From the available drawings and information, the actual level of the crib structure varies between 4.2m ODN at the landward end and 0.0m ODN at the seaward end. The overall elevation is locally higher at the landward end due to the small boulders that are covering over the groyne here (Plate 12) and the infill armour stone is locally higher on the harbour side towards the seaward end with the armour apparently having been moved across the groyne towards the harbour side by wave action, particularly where the longitudinal upper waling is missing on the updrift (south) side (as can be seen in Plate 8 and Plate 13). In addition some blocks of armour can be seen on the foreshore on the harbour side (ref Plate 9) having been displaced from within the groyne.

Plate 9: Foreshore on downdrift side of groyne, showing displaced walings and rock armour

- Removal of damaged walings;
- Retrieval of rock armour that has been removed by wave action from within the crib;
- Localised excavation and side casting of shingle from within groyne;
- Replacement of the displaced rock armour;
- Importation of a small quantity of larger rock armour for placing where there is no crib protection; and

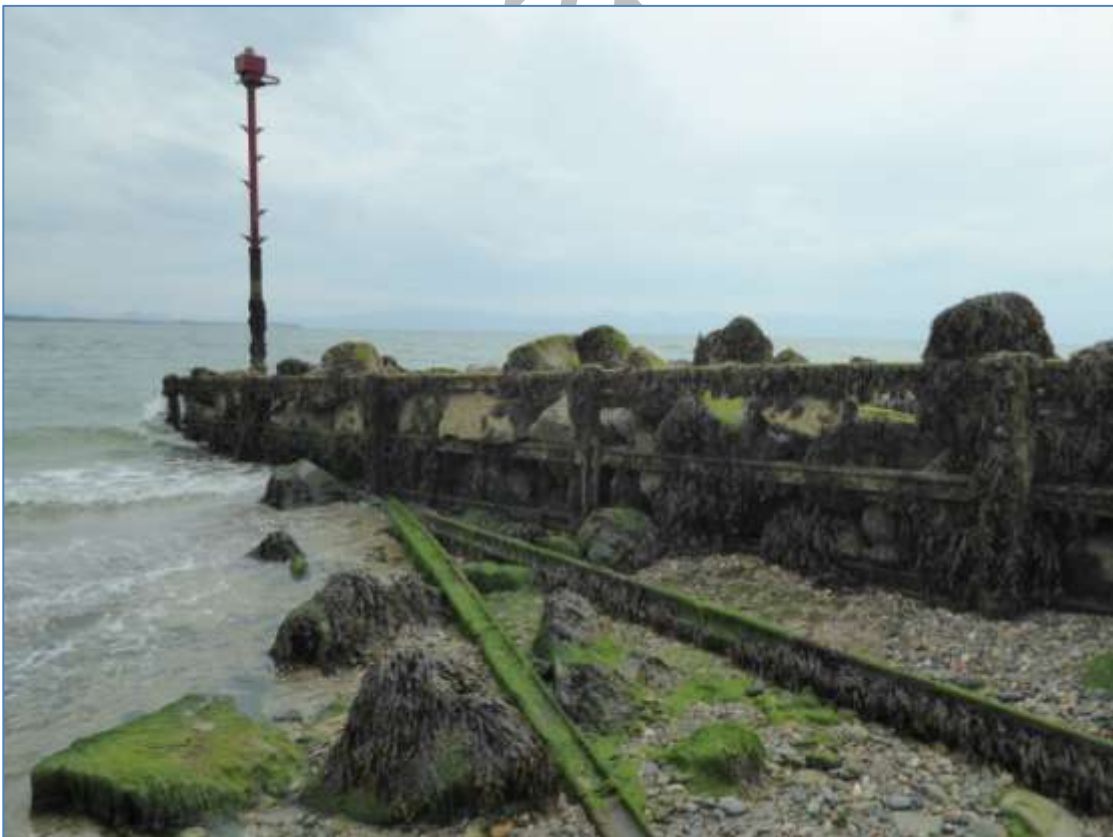
Plate 10: Seaward end of crib groyne on downdrift side

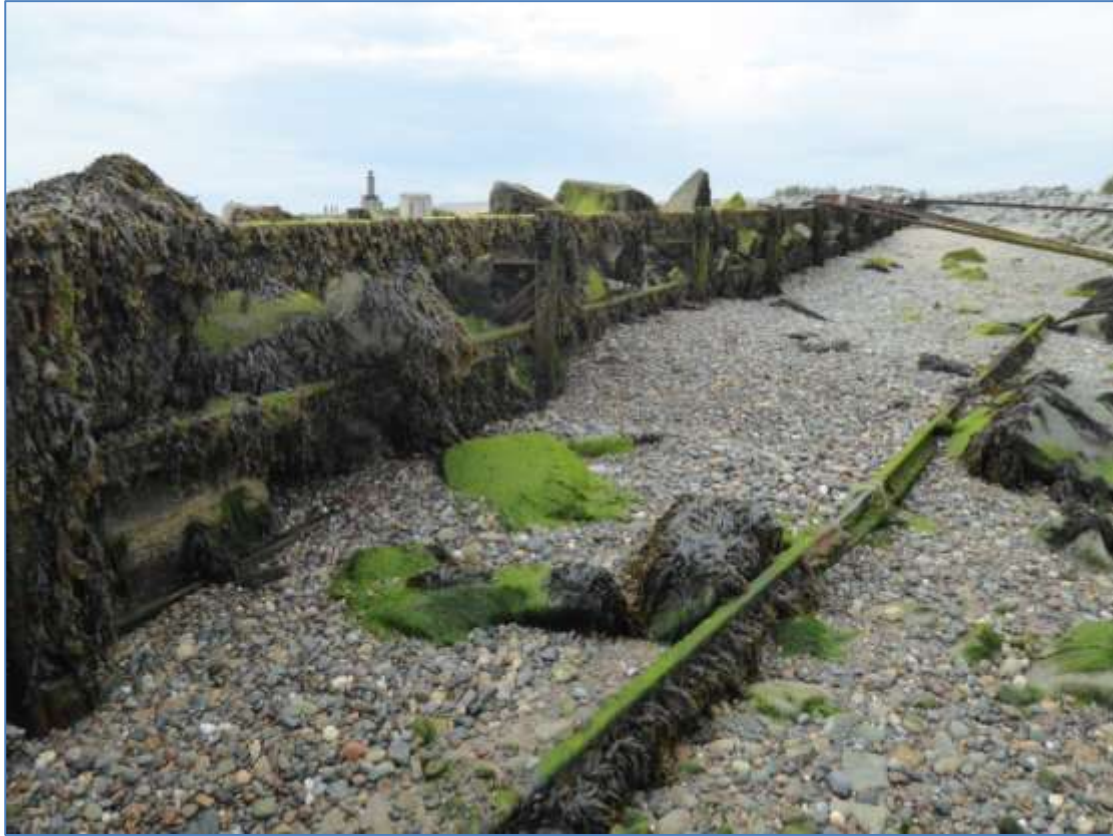
Plate 11: Elevation of Crib Groyne on downdrift side

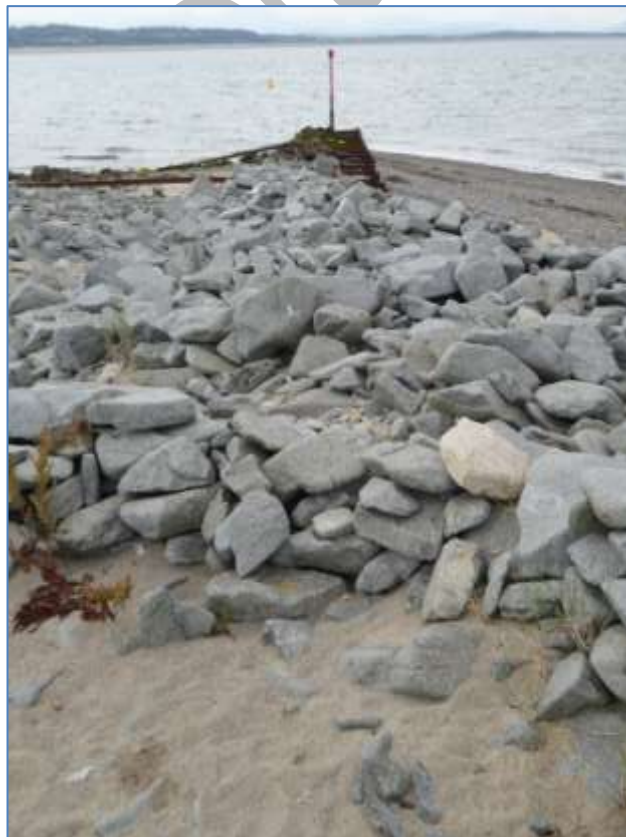
Plate 12: Rock protection mounded over landward section of crib groyne

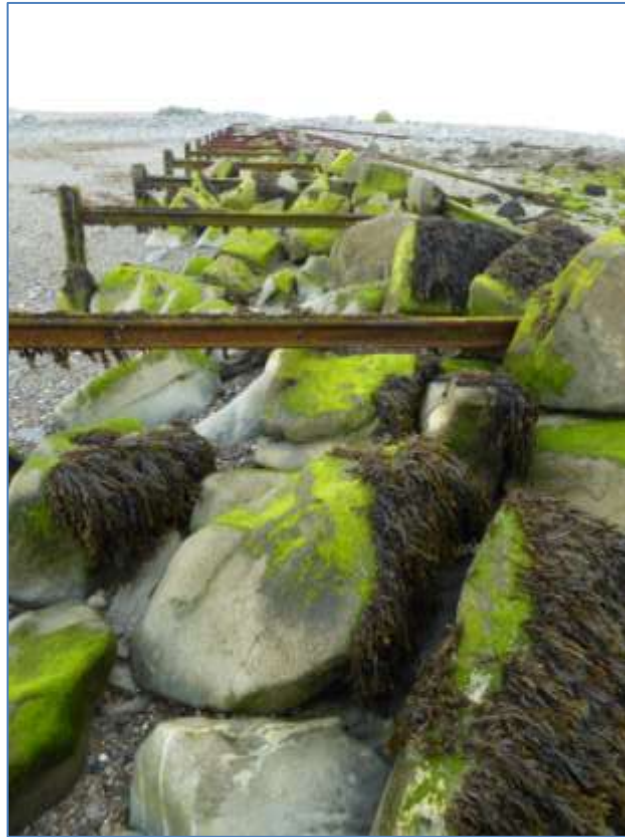
The original scheme drawings identify the rock as 1.0-1.5 tonne in size. Visual inspection of the stone size confirms this sizing. This rock is considered to be too small for the more extreme exposure conditions identified, hence the re-profiling and displacement of rock from within the crib.

Plate 13: Armour rock within groyne structure

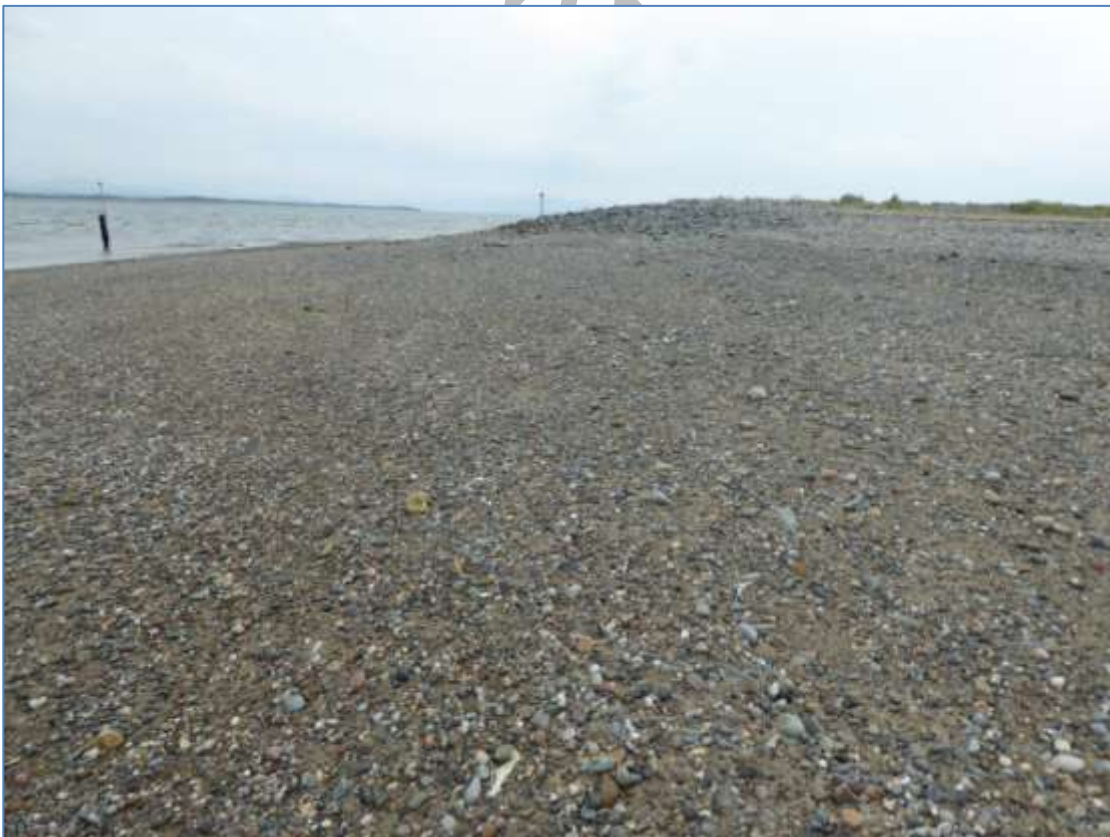
Plate 14: Beach moving from groyne into harbour

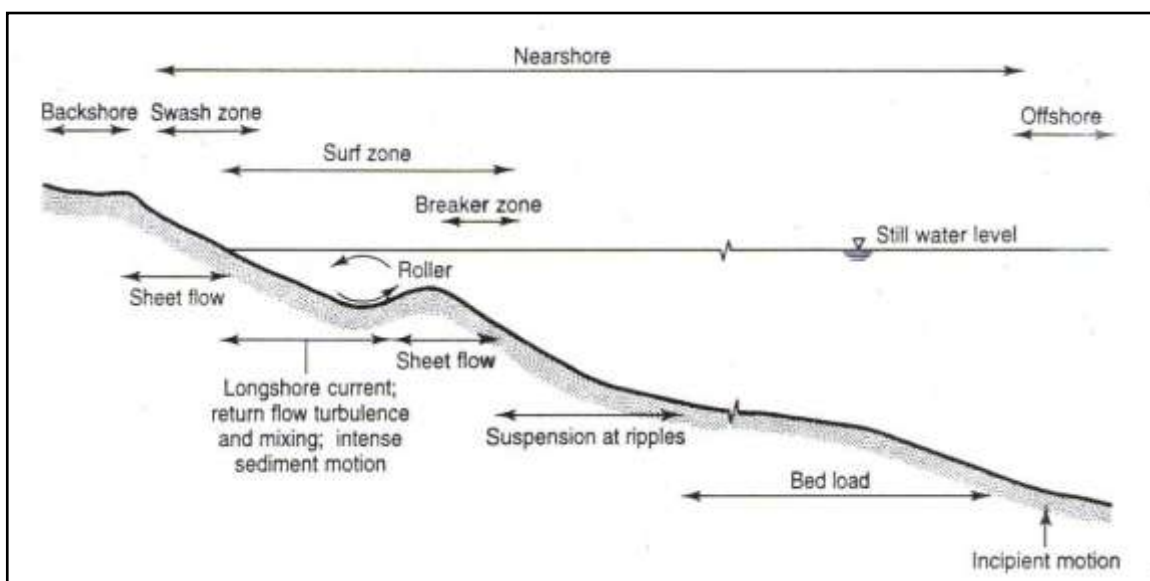
Figure C.1 – Definition of Foreshore Zones of Activity

As waves move onshore they are modified by a number of processes such as shoaling and refraction. There is a consequent spatial variation in the fluid motions at the bed. This is reflected in changes in the mode, magnitude and direction of sediment transport. These spatial changes are apparent in the morphological response of the beach profile. In the nearshore zone four major hydrodynamic regions have been identified as shown in Figure C.1 below.

- Offshore to breaker zone: In this zone waves begin to shoal as they are influenced or begin to feel the bed. Flows at the bed become large enough to initiate the movement of particles. Initially the mode of transport is predominantly bed load. As the wave continues to shoal the flows increase in intensity and the suspended load increases. Ripples are formed which are parallel to the wave crests and sediment is suspended above them.
